FORENSIC INSPECTION OF THE EPDM ROOF SYSTEM:

**Bar Harbor Town Hall**

**93 Cottage St.  
Bar Harbor, Maine**

Inspection and Report by Robert Fulmer, Principal  
Building Envelope Consultants Inc.  
(603)-828-2458

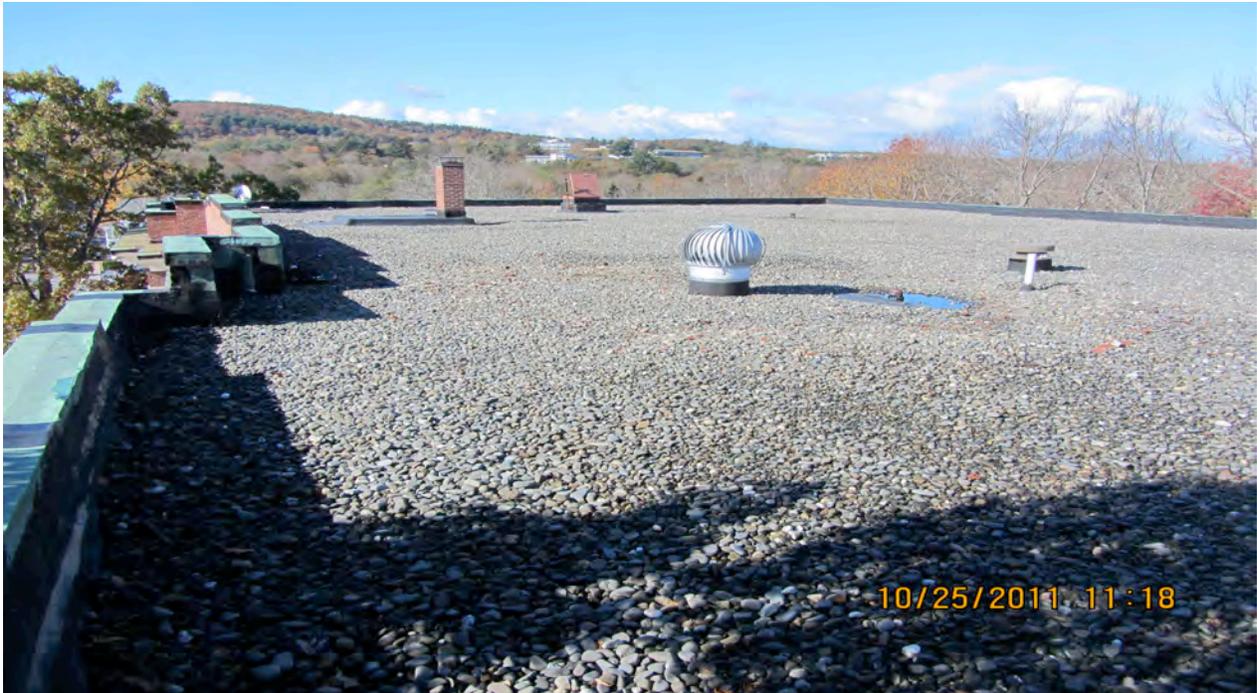
Photo 1; The existing ballasted EPDM roof system, looking toward the West elevation and the site of Test Area #1.

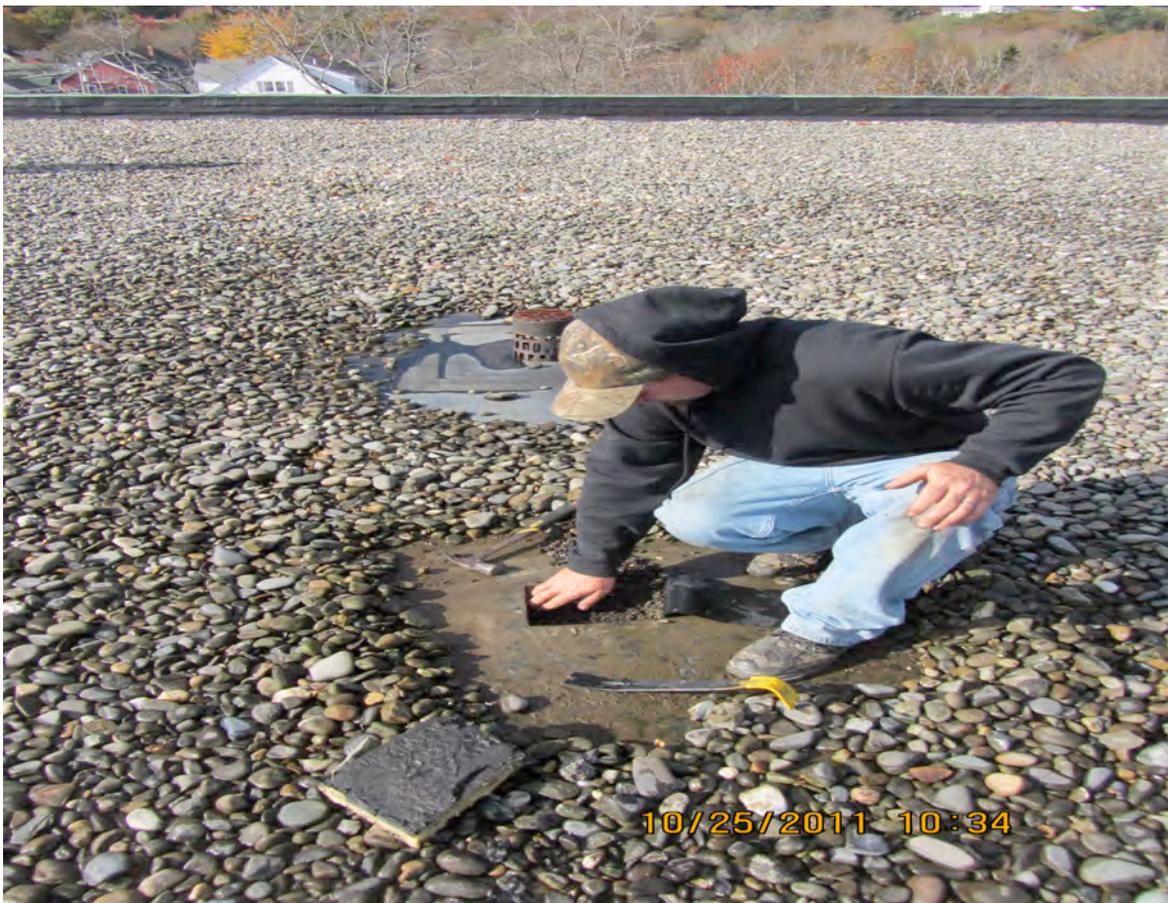
Photo 2; Preparing Test Area #1.

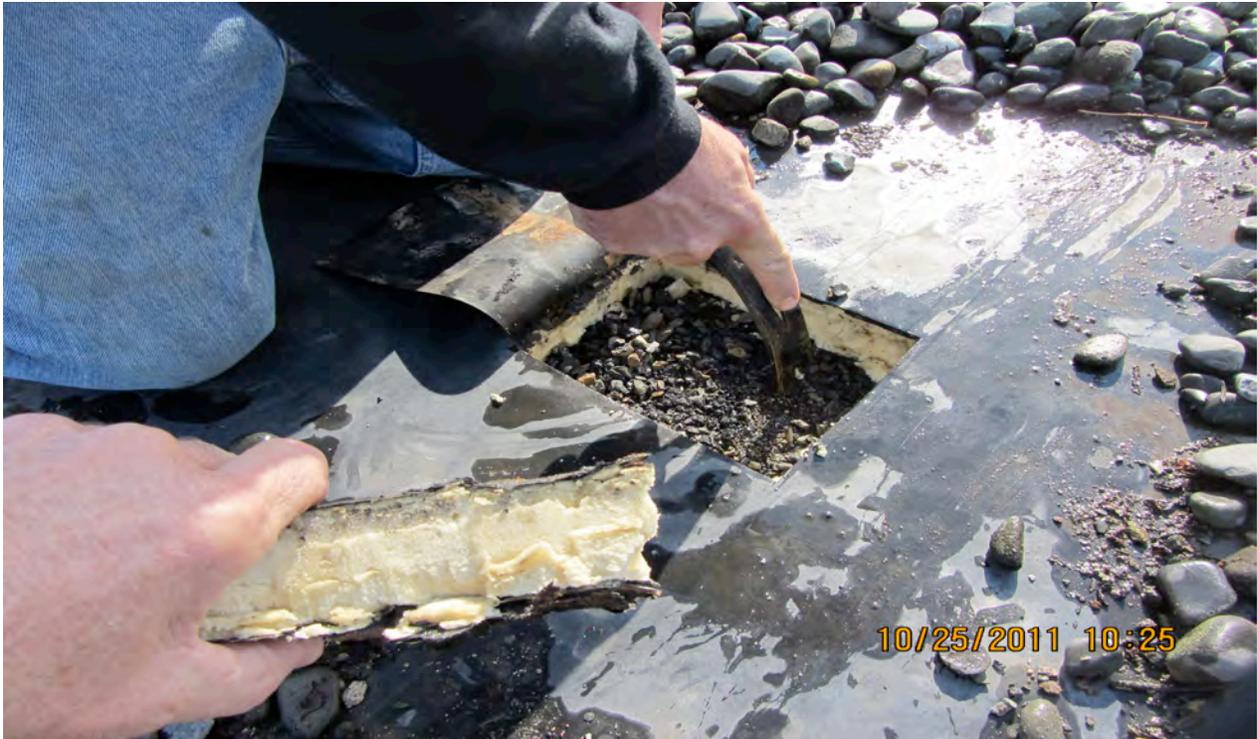
Roof System Assembly: A fully ballasted EPDM and insulation system installed over a previous BUR (Built Up Roof) system with pea gravel aggregate. An extensive amount of water was observed between the two roof systems, with the layer of "ISO" insulation completely saturated. The complete as-built assemblies were observed as follows:

Photo 3; Test Area #1. Note the BUR roof beneath the EPDM roof. The ISO insulation was saturated with significant water trapped between the two systems. These same conditions were encountered in all Test Areas.

As a result of the large volume of water observed within the roof system layers during the inspection, the entire existing roof system should be removed to the sheathing surface and replaced with a new fully adhered .090 EPDM roof system, designed to current code and energy standards.

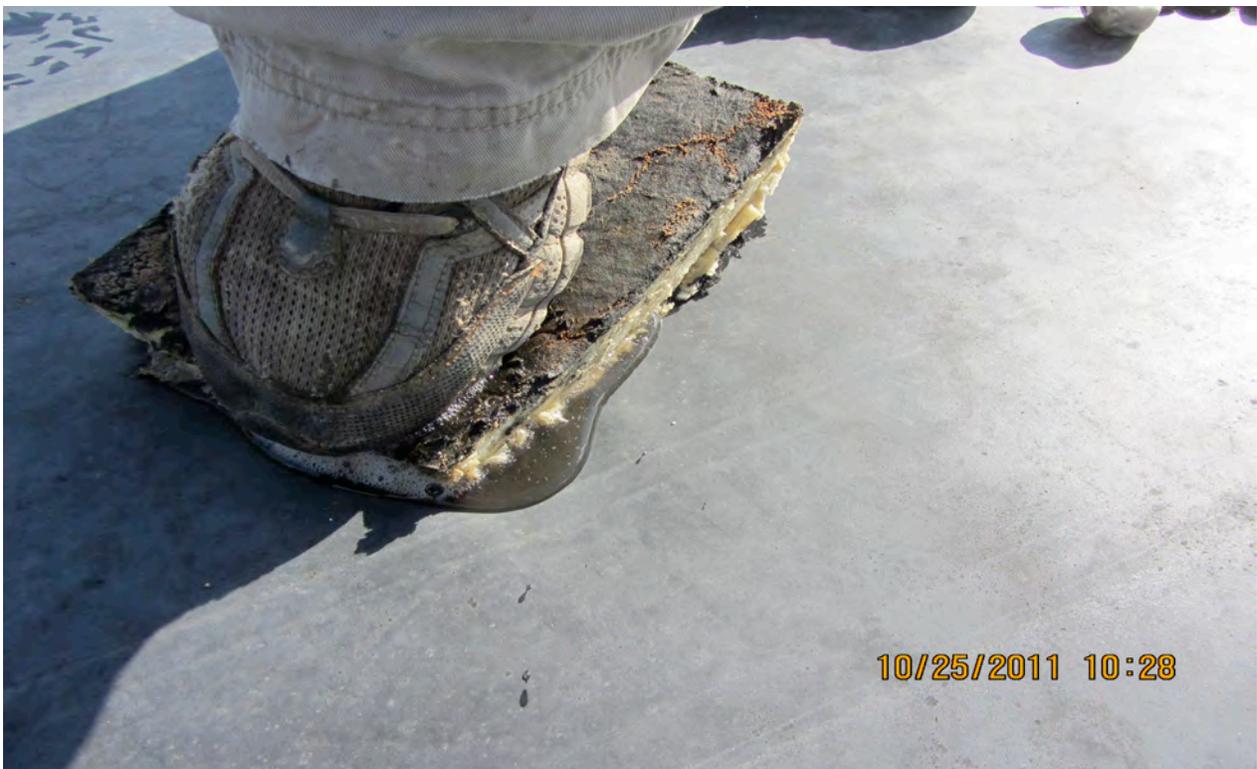
Photo 4; Showing the level of saturation within the ISO when compressed. These conditions were encountered in all Test Areas.

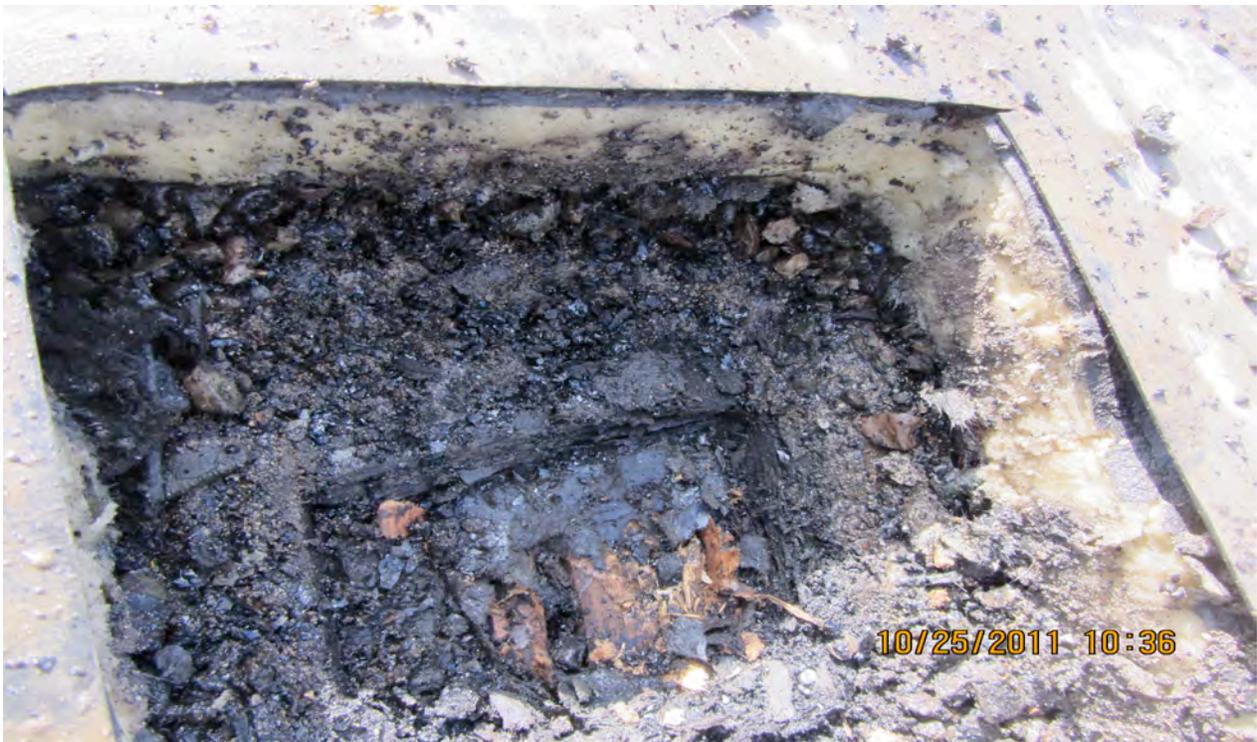
Photo 5; Showing the existing roof assembly (EPDM over BUR) down to the sheathing surface.

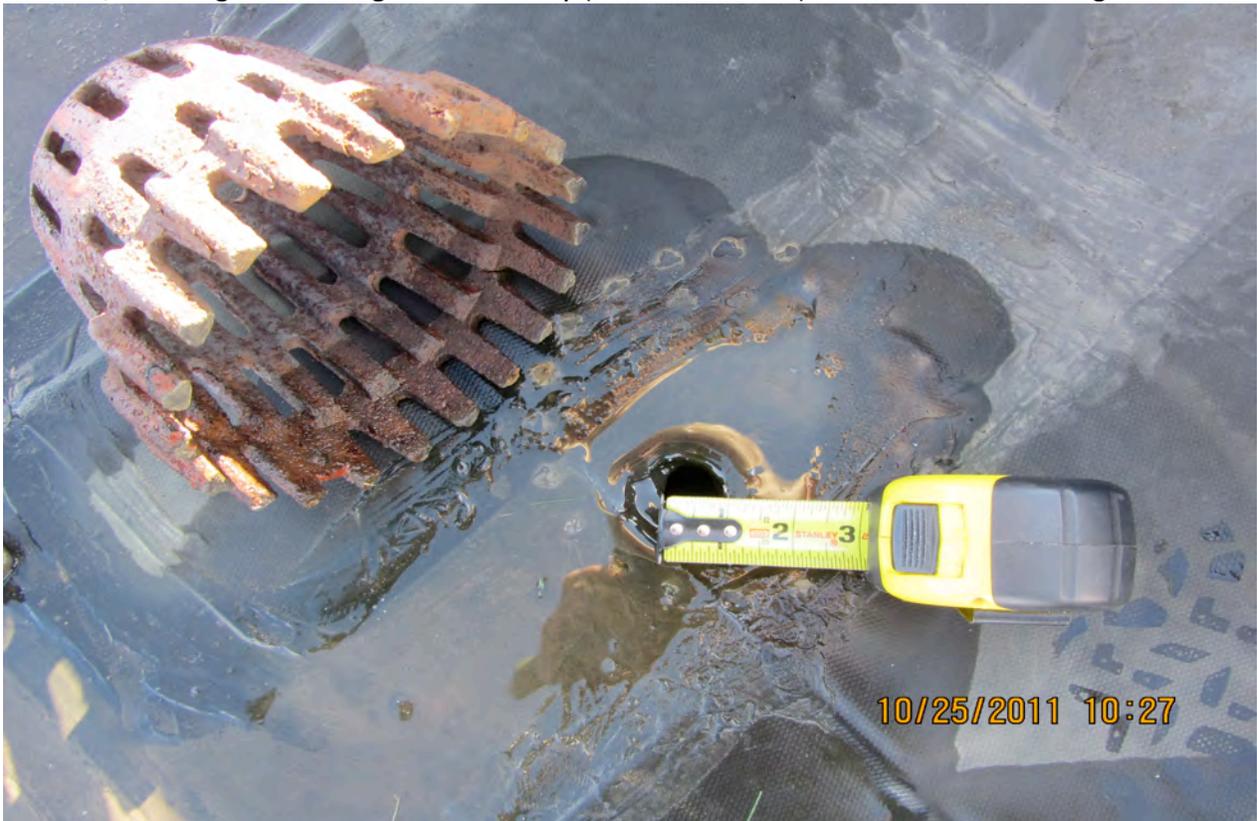
Photo 6; The number (four) and size (1 1/2") of the existing roof drains, is insufficient to drain a roof system of this size. A current and compliant drainage design is required for the new roof system.
