BAR HARBOR MUNICIPAL BUILDING

SPACE NEEDS ASSESSMENT

JUNE 7, 2013

ARCHITECT
Design Group Collaborative
Ellsworth, Maine

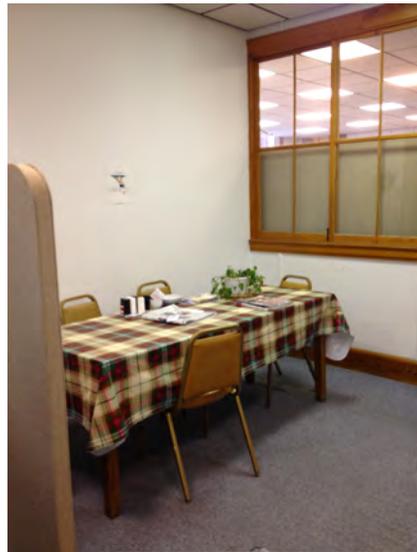
Lunch/ Break room

- The staff lunch/breakroom is located in a busy area that serves as a mail room, time clock and storage area. It does not promote group nor quiet lunches.
- Consider the need for a new locking, security card system for the building.
- The cost of renovating the existing building is substantially less than new construction.
- Rental income of approximately \$24,000/year attributed to the existing Municipal Building more than offsets the energy savings of approximately \$10,000/year for a new building.

The staff lunch room is shared between all departments. The room contains a lunch table, small counter and kitchenette, time clock, department mail boxes and storage. It was requested that the room be updated and configured to provide more privacy and less flow through traffic.

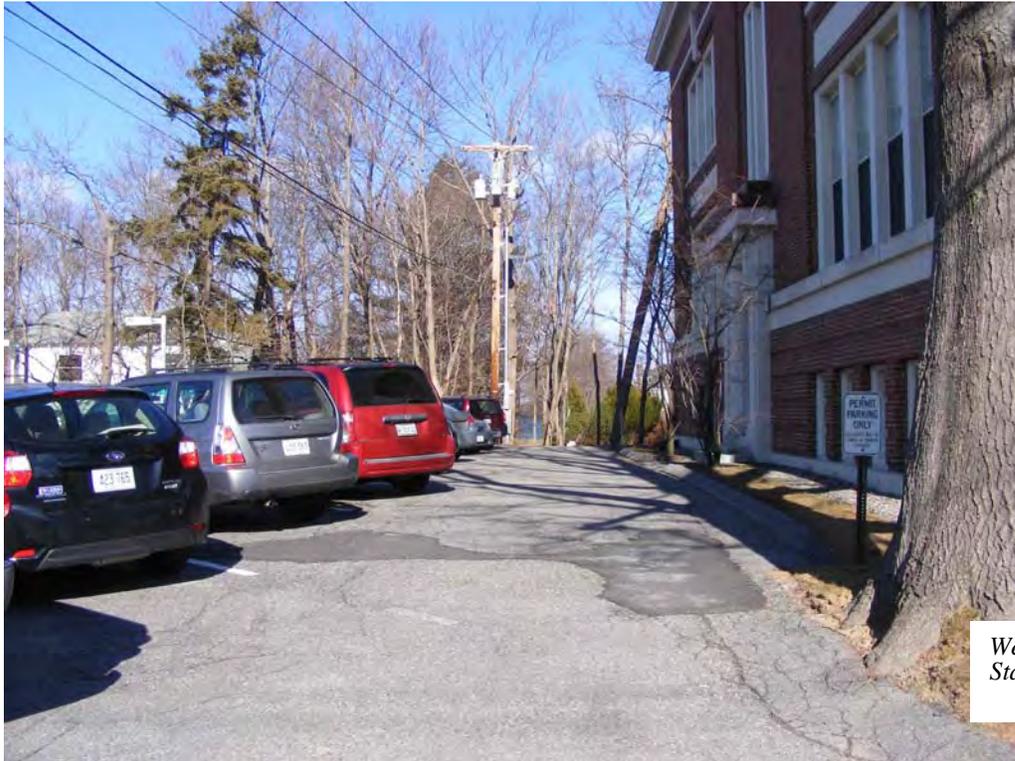
West Municipal Staff Parking Lot

There are 8 employee parking spaces located in the west parking lot. This lot can only be accessed in one direction and exited by backing out. There are no ADA spaces available for staff in their lot. The east parking lot is a public lot. There are two ADA spaces located next to the Municipal Building ADA Entrance. Town staff, employees from the surrounding businesses, the public and delivery trucks uses this lot. Availability of parking is limited in the summer. Town Water Department, Waste Water, Public Works, Fire Chief and Police Department staff who regularly do business and pick up their mail at the Municipal Building do not have dedicated parking spaces available for their use.
