NORTHEAST CREEK WATER QUALITY AND THE THOMAS BAY CLAM FLAT CLOSURE

JUNE 3, 2011

This document was produced as part of a final project for a course in Marine Policy (Spring 2011) taught by Dr. Chris Petersen and Ken Cline, J.D. at College of the Atlantic in Bar Harbor, Maine.

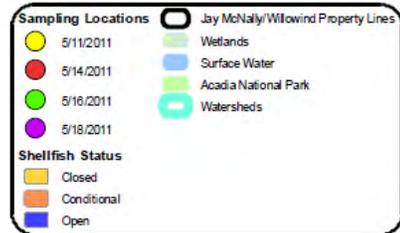
I. (B) CLOSER VIEW GIS OF AREA OF CONCERN

*Map Prepared by Michelle Klein
COA GIS Laboratory
May 2011*

Data Sources: ME Office of GIS, Acadia National Park, COA
Town of Bar Harbor, USGS-Aerials, 2004

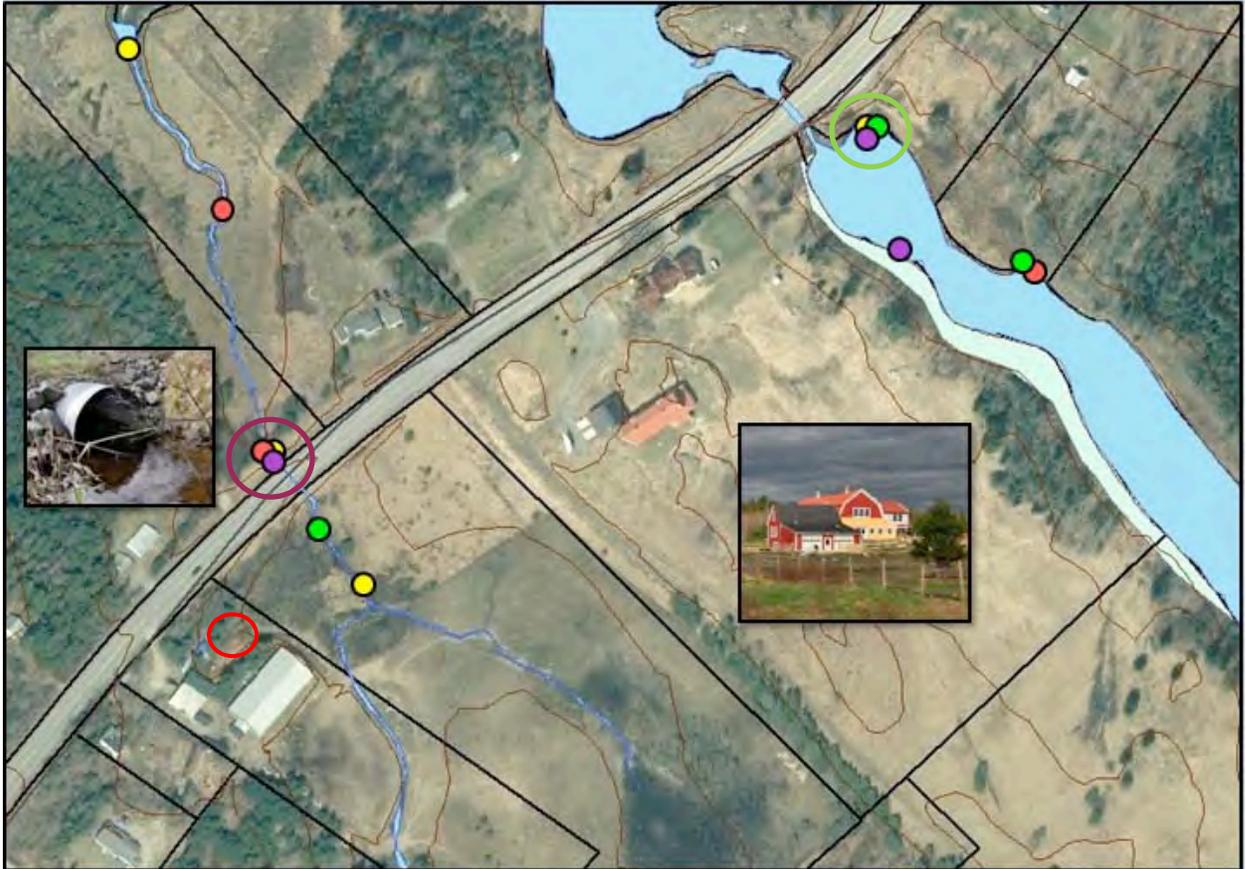
○ = MANURE PILE LOCATION

○ = SAMPLES USED IN THE APPENDIX IV GRAPH FOR NORTHEAST CREEK

○ = SAMPLES USED IN THE APPENDIX IV GRAPH (TAKEN AT THE CULVERT)

SAMPLING DATES

● = 5/16/2011

● = 5/11/2011

● = 5/18/2011

● = 5/14/2011

This graph shows the increase in CFU levels concurrent to the rainfall event of May 16, which was the highest rainfall event of the month. Samples before this point showed consistent low levels, and after the rain event, CFU numbers dropped. For both samples with elevated counts, the Northeast CFU numbers were higher than the samples collected at the culvert. Given the low permeability of the soil in this area, this result is also evidence that the area is prone to high amounts of runoff with rainfall events. Precipitation data was collected from the wunderground.com/history of Bar Harbor, ME precipitation. Both of the site locations are highlighted in Appendix I(B).

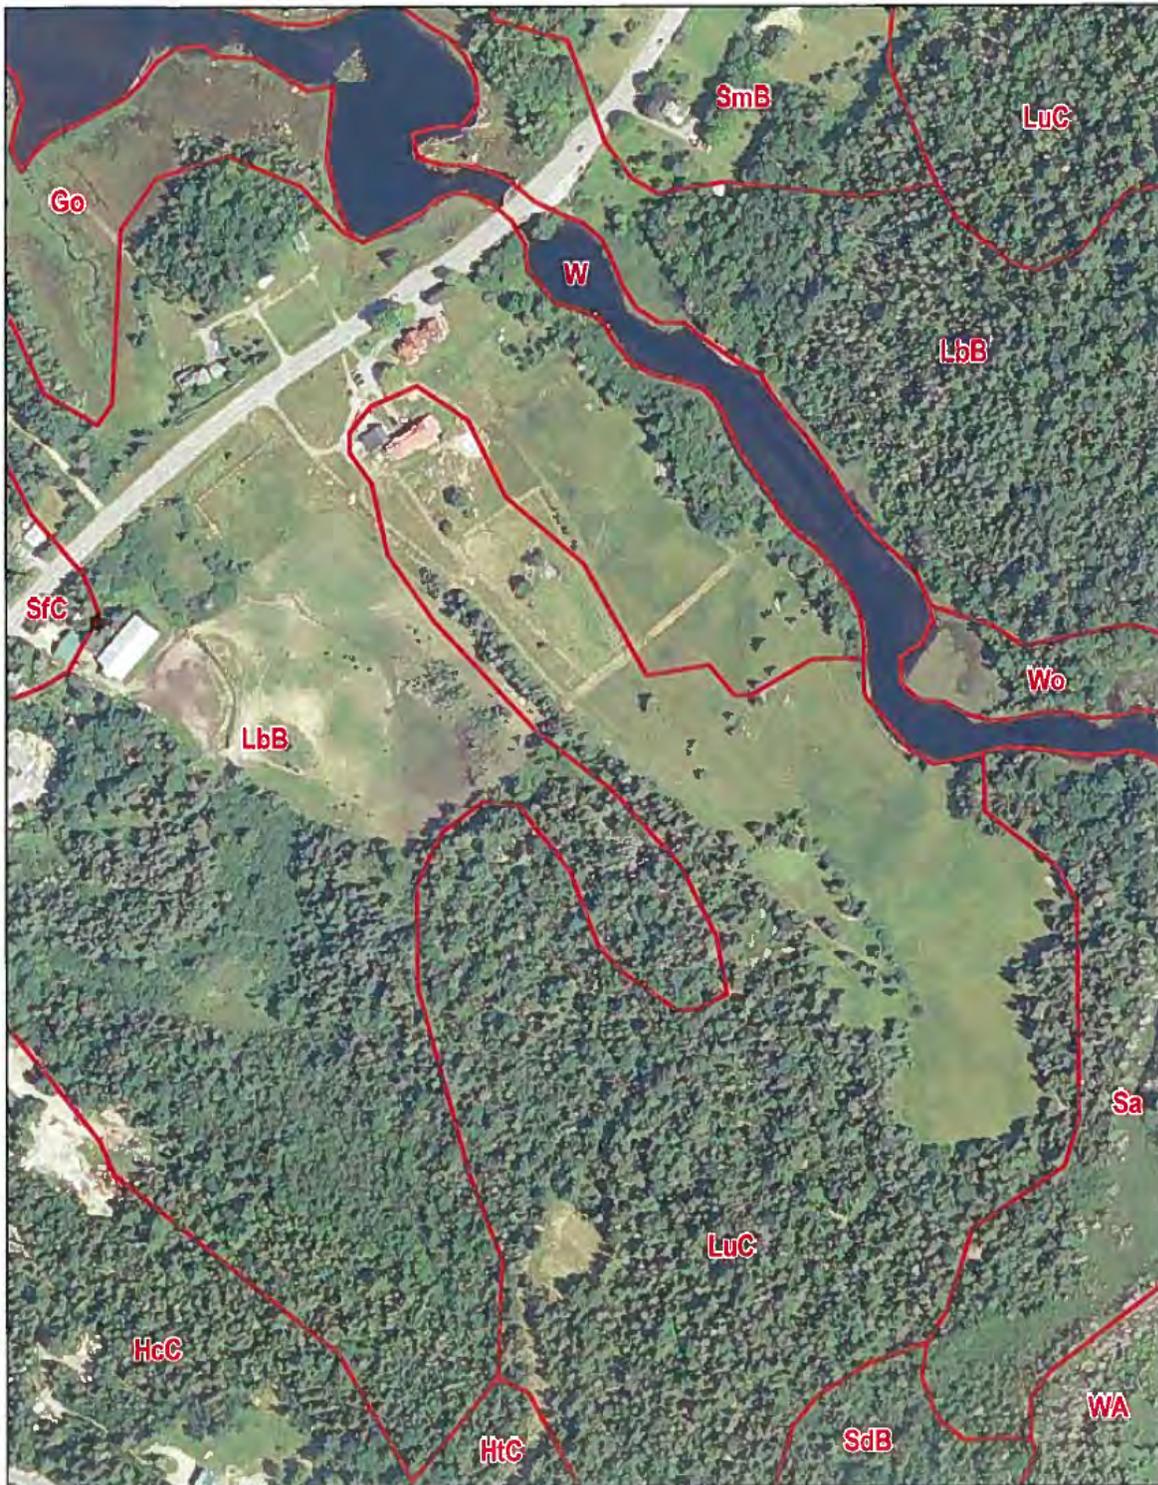
VIII. GIS SOIL PROFILE OF THE AREA (PROVIDED BY ROLAND DUPUIS AT THE NRCS)

1 inch = 300 feet

LbB= Lamoine-Scantic complex

The land surrounding the Northeast Creek watershed is Lamoine Scantic Complex, or LbB soil, which is characterized by poorly drained Lamoine and Scantic soils (Appendix VIII). Lamoine Soils also have a perched high water table, which is only between 6 inches and 1.5 feet deep (USDA, 1998). Soils with high water tables have less capacity to hold nutrients, so it is harder for microbes to attenuate concentrations of nutrients before they run off the landscape. The LbB complex is composed of 6-7 inches of heavy silty loam covering clay loam: these fine-particled soils have low infiltration rates and are prone to increased runoff. (USDA,1998). The USA National Cooperative Soil Survey lists use for this scantic soils as "mostly idle or woodland, some areas are used for growing hay and pasture," these all constitute impact activities that will not exacerbate the poor drainage of this soil through further compaction.

and LuC (Lyman-Tunbridge) soils (appendix VIII)—have poor drainage and a high water table which reduces their capacity to hold nutrients. The permeability of these soils is compromised further with high levels of compaction from agricultural land use. Runoff is a serious factor to consider when looking at mitigating the impacts of land use decisions.
